# 117 / 560SL Engine Dress-Up

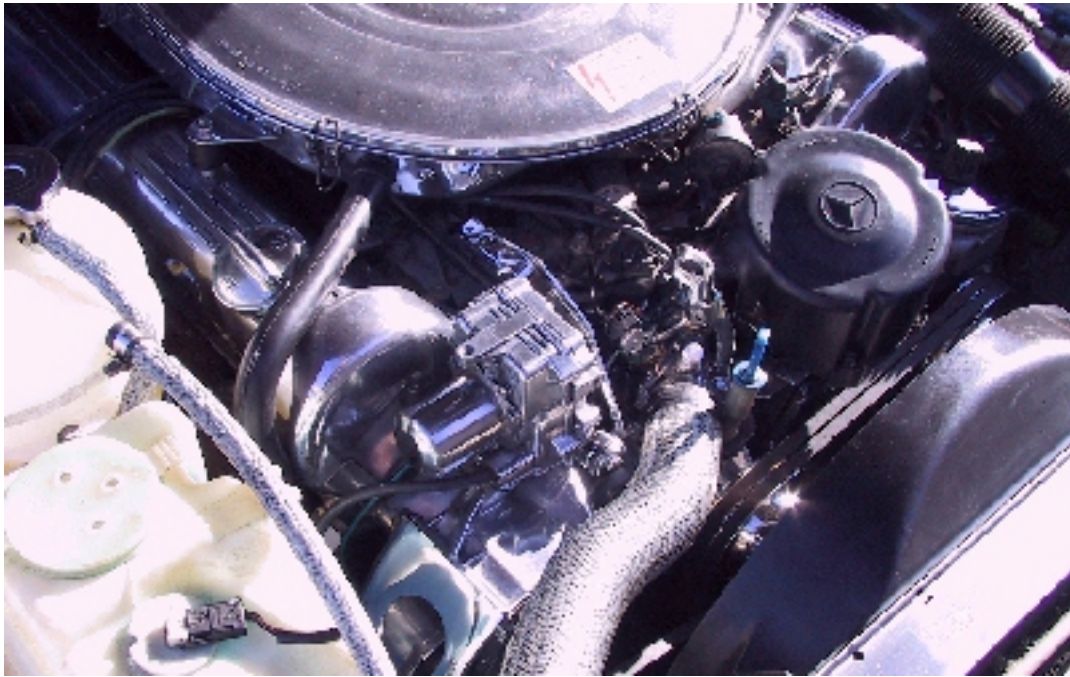
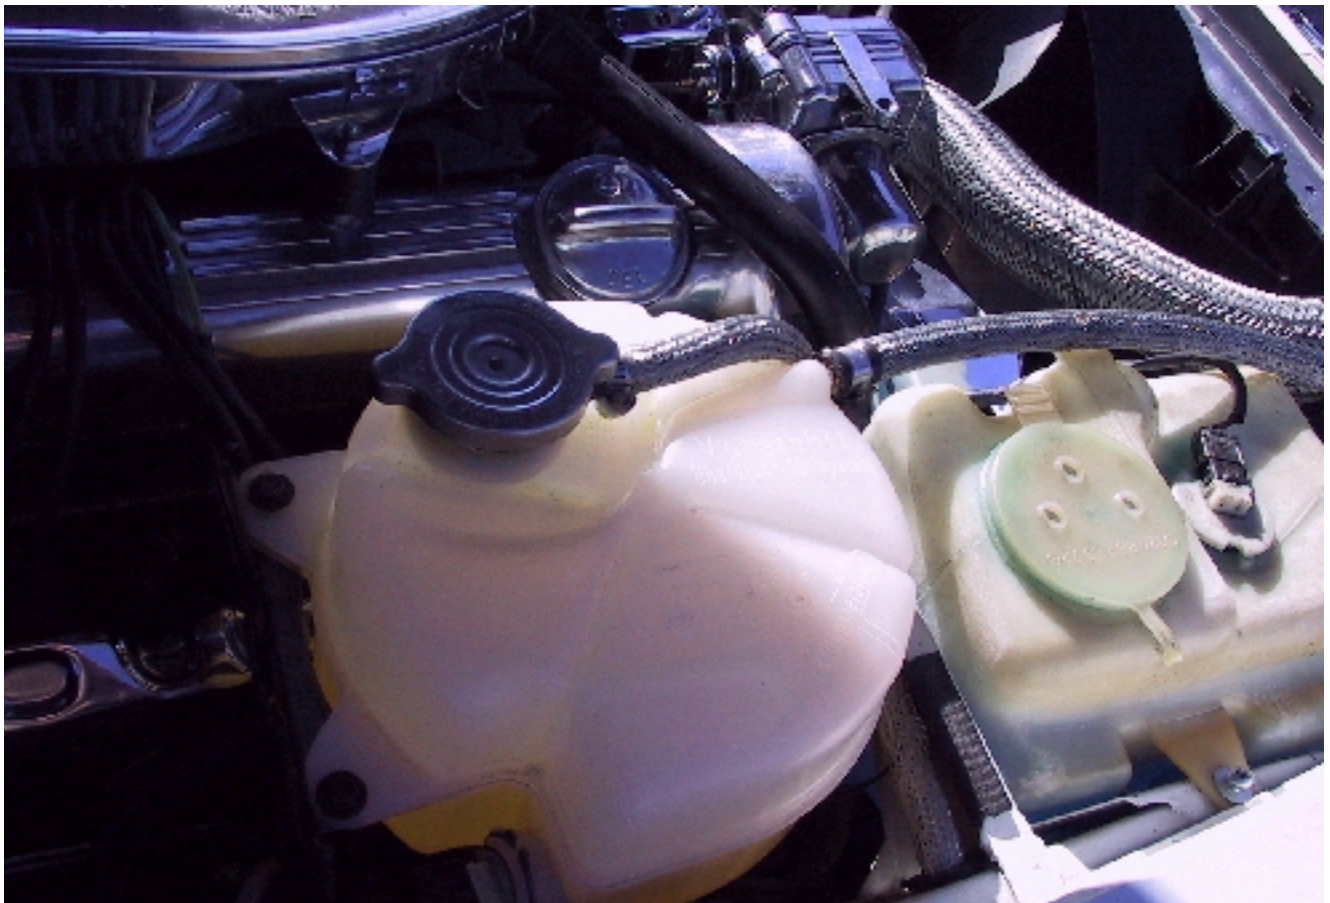
I know that purists will not like this, but I finally finished my dress-up stuff as far as I'm going to go. I had earlier buffed out (with a buffing machine and industrial polishes, wheels, and bits) the valve covers and air cleaner. I don't drive my car in the winter, and never deliberately in rain; my experience has been that a thin coat of oil (just about any oil) once in a while will help keep aluminum looking nice.

The air cleaner was fairly easy (but with a few pits I didn't remove); the valve covers were not easy - the castings are pretty rough (it seems that later valve covers are less rough, as I did two sets). My results with valve covers aren't perfect, but you can see yourself in them. If you buy spares for yourself, look for cracks. Jumped timing chains are the usual COD on these cars, and that's why a lot of valve covers in the junkyard are cracked (particularly the left one).

I did the fan, which was very difficult (in fact, I did two) and seems to be made of an aluminum alloy that corrodes quickly. I sprayed wheel clear over it shortly after repolishing the second time. I did not go to extremes on them to remove pits because I was concerned about strength and balance. As far as I can tell, I did not significantly affect the balance of the fans (been using one for more than a year with no ill effects to the fan clutch or water pump).

The water pump - a very difficult and nasty job due to the odd shapes and nooks and crannies. After replacing my original water pump, I polished up my old, non-leaking (yet) pump for practice, and I liked it; then I bought another one, polished it, and put it back on. Then I polished up the one with about 3K miles on it. The upper and side fittings (the top neck and thermostat housing) were also polished. The side one was easy, the upper one was very difficult. BTW, the temperature sensors on top polish up brass very nicely!

The power steering pump lid - I think that this is made out of cast zinc, and not very well turned. I don't have a lathe, so I took a screw and nut, "bolted" it to the chuck of my \$40 drill press, and let it rip, sanding it with various sandpapers, finishing with wetordri and polishing. Once this was done, it really polished up nicely - at first, it was the worst looking thing I had polished; now, it's the best.

The alternator mount - a VERY rough casting, took a lot of work. I polished the one on my car and a spare.

The distributor-a nice casting, very easy, except for the nooks and crannies. Actually, I did two of them.

The alternator - This is surprisingly easy once you remove the pulley and get the case apart (which took an impact screwdriver). The castings are actually very smooth. I also replaced the regulator/brush assembly. I had purchased an upgraded 80A alternator which is a little bigger and is tight, but it does fit; the newer alternator uses lugs and studs/nuts for connection, not a plug; I had to rewire this connection (not difficult, but a PITA to route the wiring through the insulation jacketing). After doing this, I polished, re-regulated, and had chromed the pulley/fan of the original alternator. Naturally, I used the handy European mm cross section to English AWG converter at the beginning of the 107 manual's electrical section when sizing the wiring.

The accellerator servo - not too difficult with the small polishers and dremel; the domed part is steel, contains the magnets for the servo motor, and I don't think it could be chromed; I polished it. We will see if I can keep rust off of it (See below). I wanted to see how these worked, so I acquired two spares, which I also polished and tested.

I had chromed:

The front engine lift hook

The alternator adjusting arm

The water pump and power steering pump pulleys, nuts

The alternator fan and pulley (actually, the "pulley" is two pieces), and nut

The accellerator servo mount. I also replaced the rubber isolation doughnuts and the rubber mount underneath; getting those doughnuts in took near-boiling water and a lot of swearing.

The heat shields - one is very easy to remove/install, the other requires lifting out the EGR; I bought another gasket for this purpose. They look nice, but now the exhaust manifolds look comparatively worse. Well, maybe next year I'll have them jet-hot coated.
