MB107 Center Vent / Defroster Relationship

Reviewing Center Vent/Defroster Relationship on a 1988 560SL (R107)

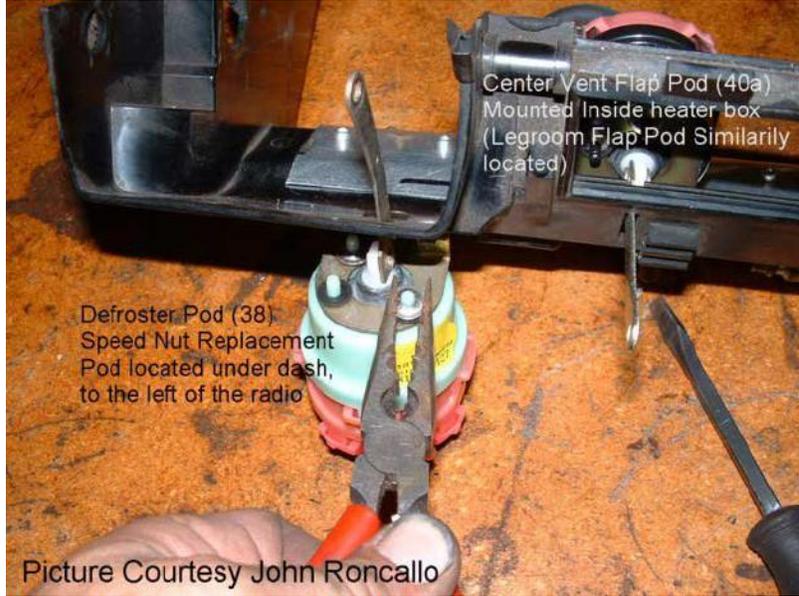
Unfortunately, there is another failure mode of the center vent actuator. If you find you can open the center vent by inserting a rod into the vent and gently forcing the vent open, and it stays open, then you have a broken heater box/pod mount.

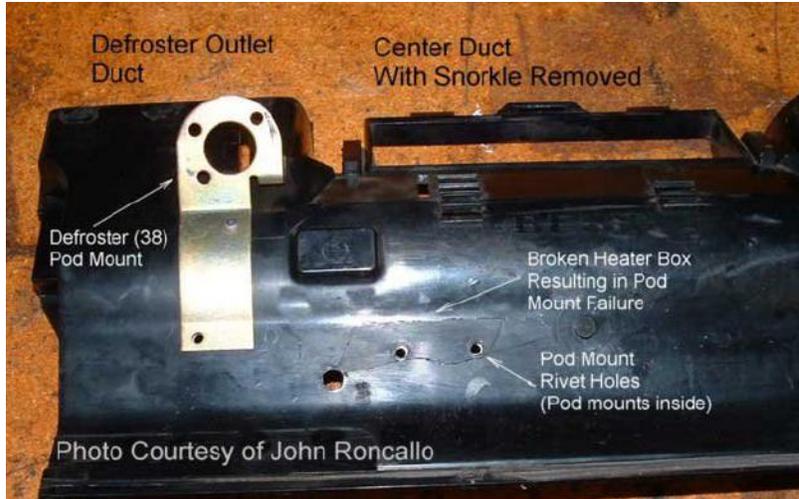
What happens here is the pod breaks out a section of the heater box wall that it is mounted to, and no longer operates the flap. In this case, heater box removal is also necessary to remove the pod, fix the broken heater box, and repair pod function. If you want visual confirmation, remove the radio from the console. You will be looking straight at the heater box where the two rivets of the center pod mounts are located. If the heater box is broken, it will be obvious.
