Mercedes Benz 107 Cracked Heater Box Repair

Cracked heater box removal, repair and replacement in a Mercedes Benz R107

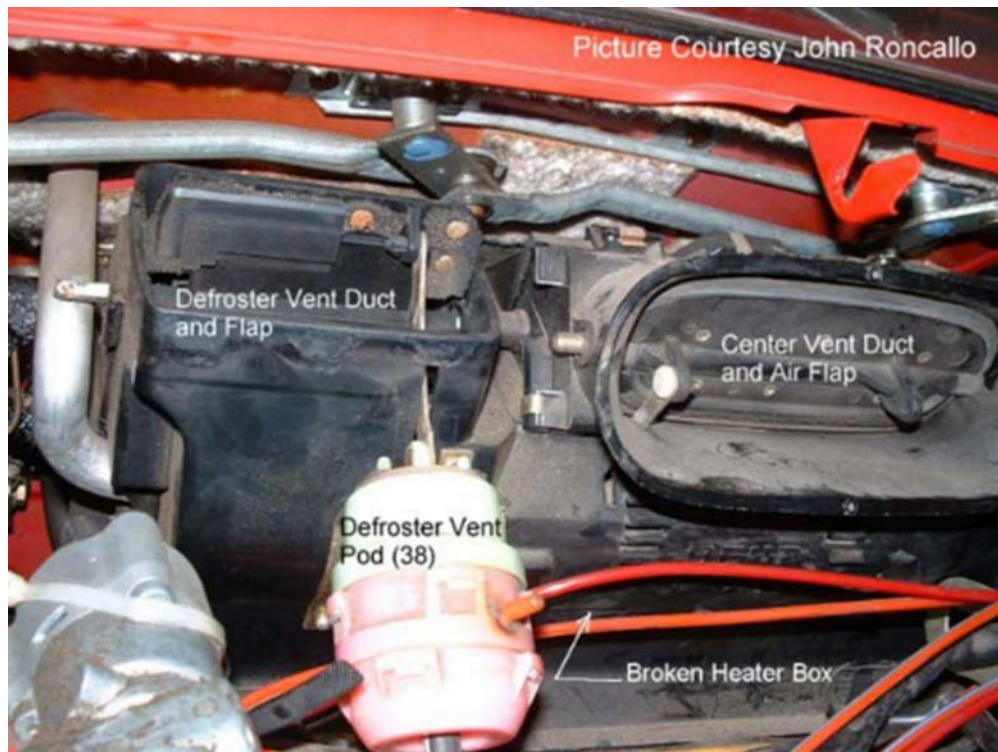
Here is what greeted owner, John Roncallo, when he removed the console and dash. Note the deteriorated defroster flap foam seal and the cracked heater box.

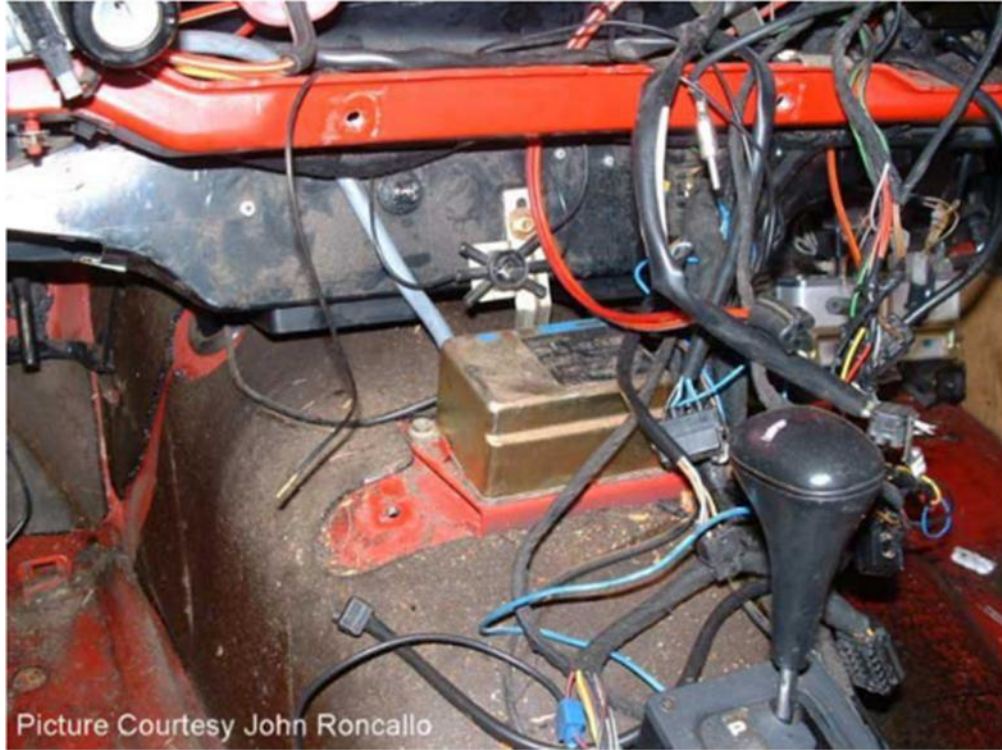
Here is the lower half of the heater box prior to any repairs. You can just see the cracked heater box at the top of the picture.

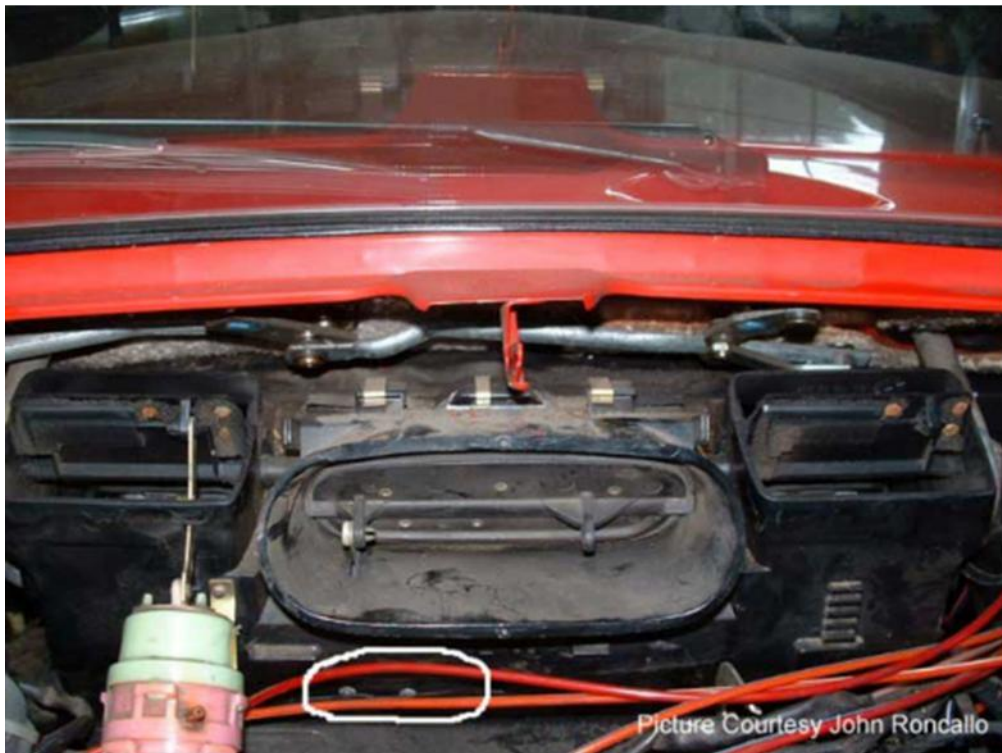
Another view of the top half of the heater box, prior to any repairs. The circled area is where the center pod mounts, and is visible when the radio is removed. Notice how a section of the heater box is completely broken loose, and dislodged downward as to hide about 1/2 of the mounting rivets.

The two defroster vent flaps are visible in this picture as well. The actual vent ducts are attached to the underside of the dash, and lift away when the dash is removed.

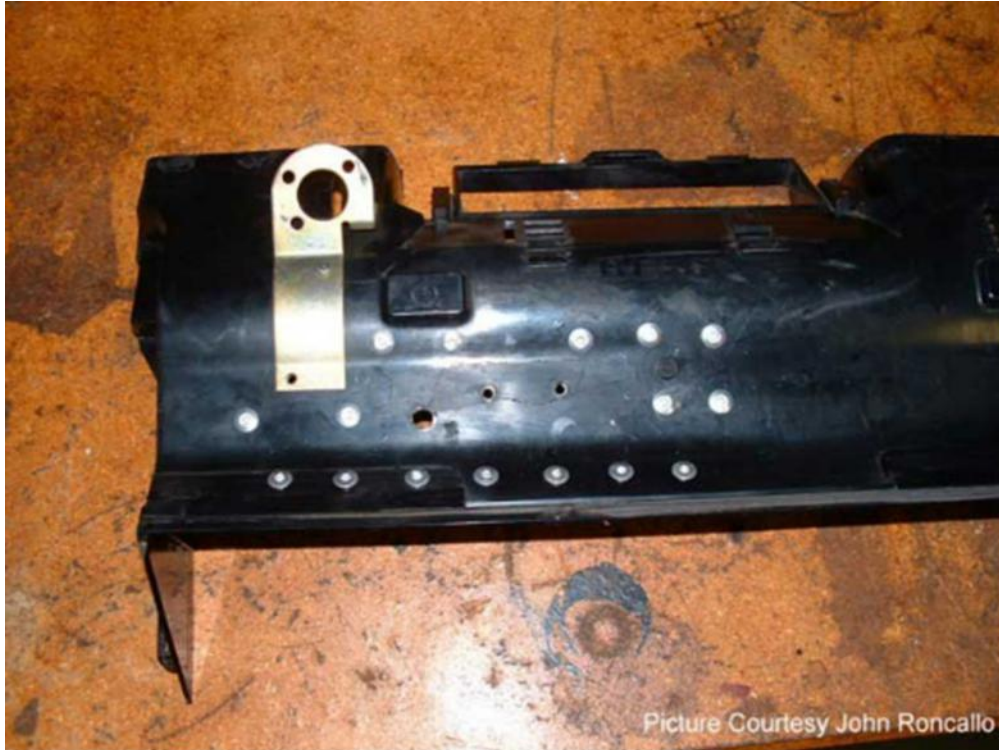
Here is the repaired housing from the front view. Note the size of the cracked portion of the housing, just visible around the two rivet holes. The larger hole to the left and a bit lower is where the vacuum line attaches to the pod after it is mounted inside.

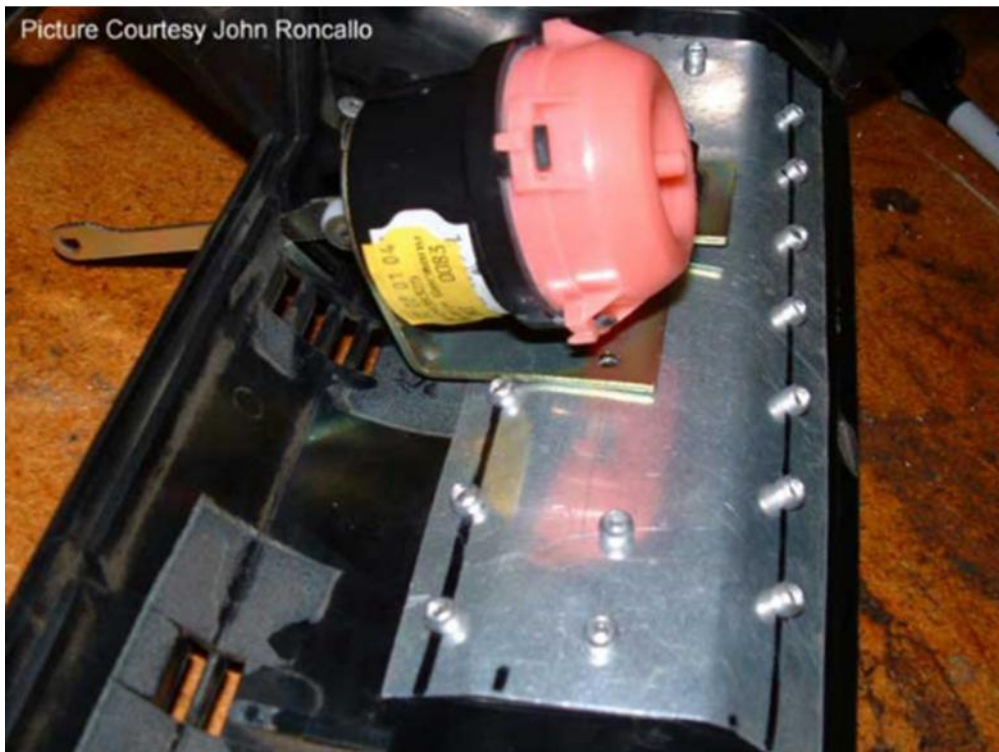
Here is the repaired housing with the center pod mounted in place. This is a view of the Inside of the top 1/2 of the heater housing.

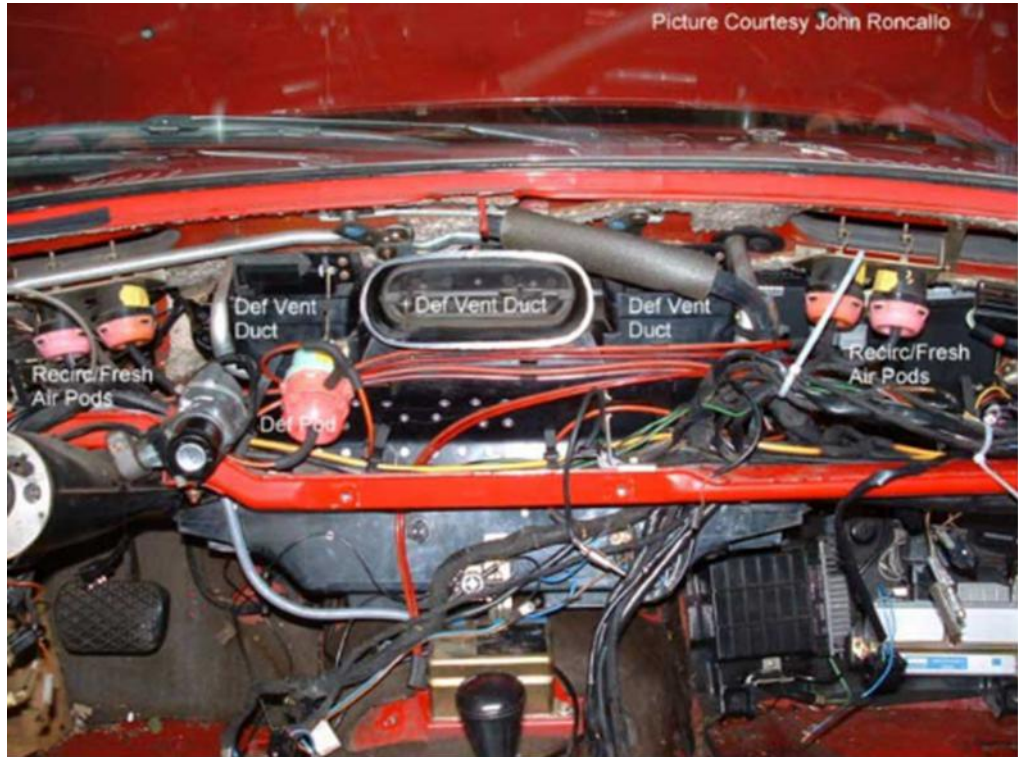
5 of the seven pods can be seen in this view. A careful observer can also pick out where the other two are by where the vacuum lines

attach. Notice the def pod. See how the vacuum line tees at the center, and runs to the center pod. This shared vacuum line is why diagnosis is somewhat difficult. A leak in either renders both inoperative.

Note also the new foam seal installed on the def vent flaps. This is how a repair should be done. The foam hose lying across the right def duct is the ambient air sensor tube. This foam hose serves as a conduit for ambient air to be drawn across the sensor to regulate temperature. When this hose deteriorates, the sensor cannot sense the inside air and fails to regulate the temp and fan accordingly. Its replacement can be facilitated thru the glove box.

Here the repaired heater box is re-installed in the car, and the vacuum lines are attached. Now to put the rest of the car back together.
